Fiber Cleanliness in the Data Center – The Impact of Contamination

Authors:
Martin Hempstead
Eric ten Have

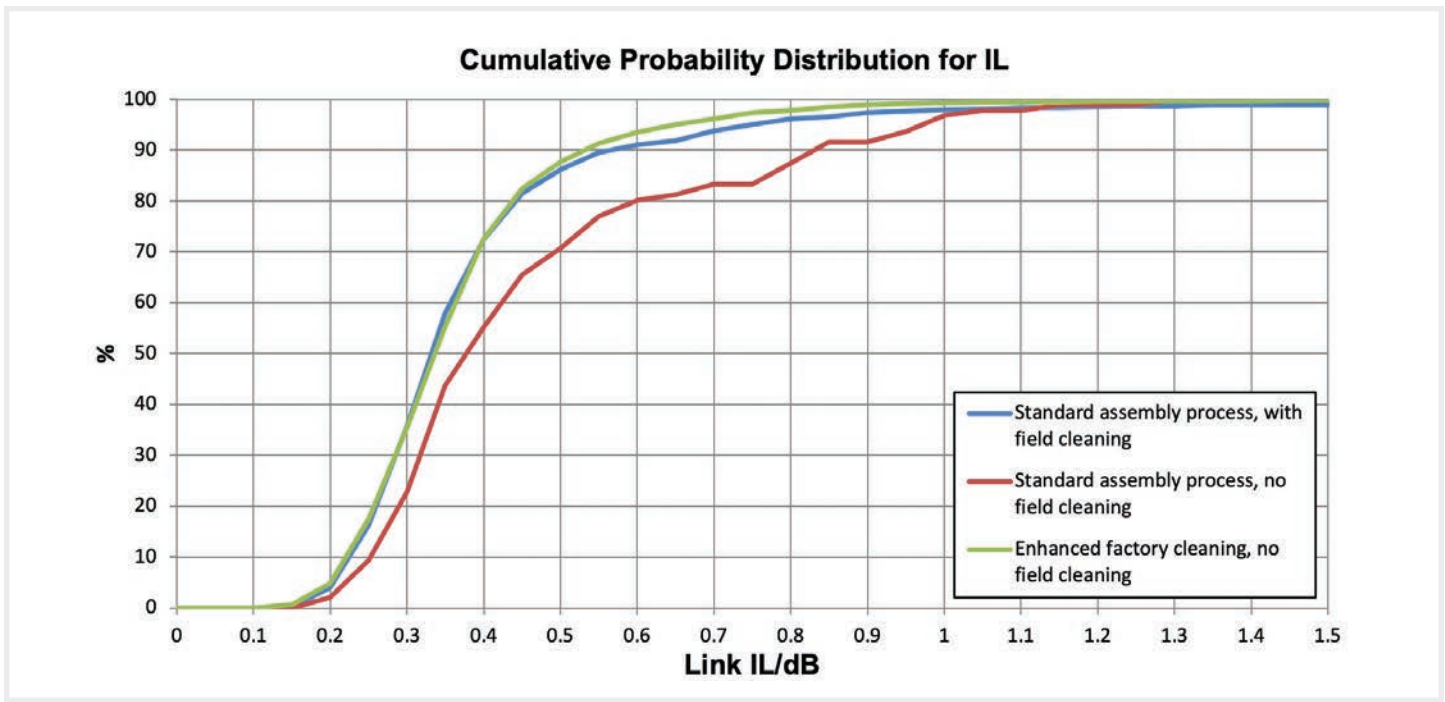
Figure 1: Comparison of IL measurements of a typical link architecture for the current process (standard assembly process with field cleaning, blue line) and the “no cleaning in the data center” case (enhanced factory cleaning without field cleaning, green line). Links consisted of two 12-LC to 1-MPO modules connected by an MPO-MPO jumper. The data shows that enhanced cleaning and the use of optimized caps assembled without field cleaning can perform equivalently or better than the current standard process. Data for standard product assembled without field cleaning (red line) is given for reference and performs worse than either of the other products.

We have tested the practicality of this by measuring the insertion loss (IL) on a large number of MMF links like those that would be installed in a data center (Figure 1) using various cleaning paradigms. The results strongly suggest that products treated with an optimized cleaning process, as well as caps assembled without further cleaning (the “no cleaning in the data center” case) can perform as well as or better (in terms of IL distribution and number of IL failures) than product cleaned in the “field” just before link assembly.

It is thus of utmost importance to clean the entire end face to prevent debris from moving into a critical location after the final inspection. This will help deliver good IL performance of connections in the data center even without field cleaning (Figure 1).

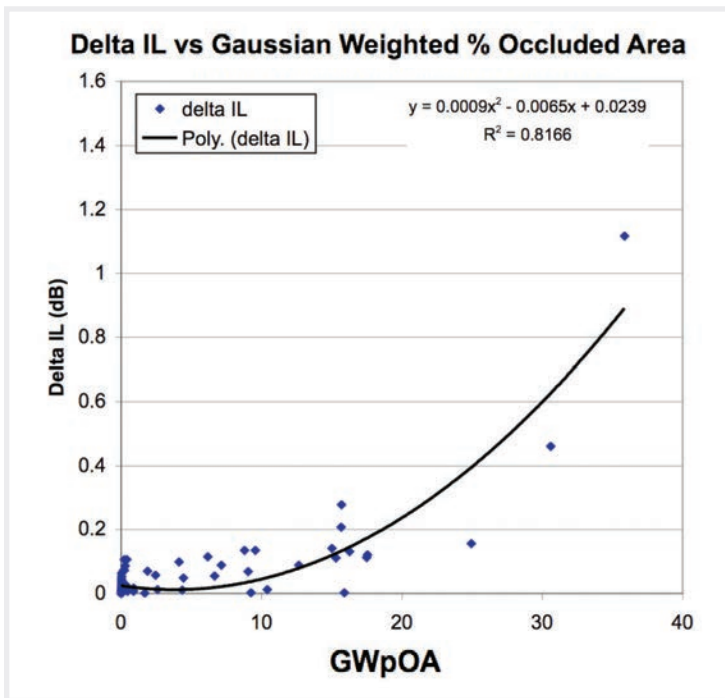
Figure 2: From reference [1]. Excess insertion loss due to debris as a function of the Gaussian-weighted occluded area (GWpOA). The data points (Delta IL) are fitted to a quadratic trendline.

This model can explain part of the IL performance, as seen in Figure 2 below taken from reference 1, where a clear correlation between the measured loss and the loss estimated by this process is shown. But the best-fit polynomial prediction is very far from perfect, falling well short of what would be required to implement pass/fail criteria with low false positives or negatives. Moreover, the magnitude of the loss is not consistent with the Gaussian-weighted occluded area – for example, if 30% of the power was absorbed or blocked, the expected loss would be 1.5 dB, not the 0.6 dB shown on the best fit.

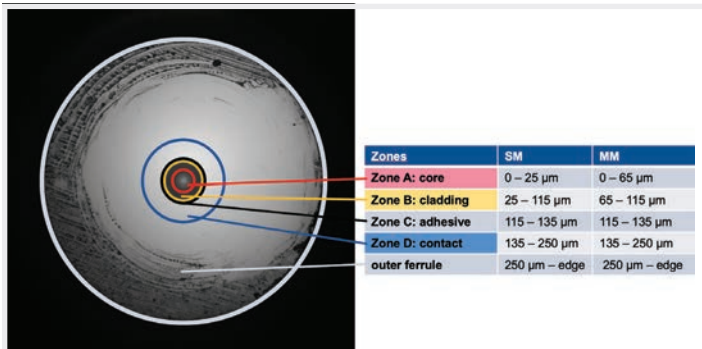
Figure 6: IEC inspection zones for a multimode LC connector (end face after deliberate contamination with oily material then cleaning with “clicker” cleaner stick).

Figure 13 shows a connector end face deliberately contaminated and cleaned with a clicker cleaner stick. This connector passes inspection by the IEC standard as the contamination is located outside the inspected area (zone D in Figure 6). If the contamination is only loosely bound, it can travel from the edge of the end face to the fiber area through handling or capping even without direct physical contact. We have observed instances of contamination moving through electrostatic forces or air movement during repeated cap/uncap cycles.

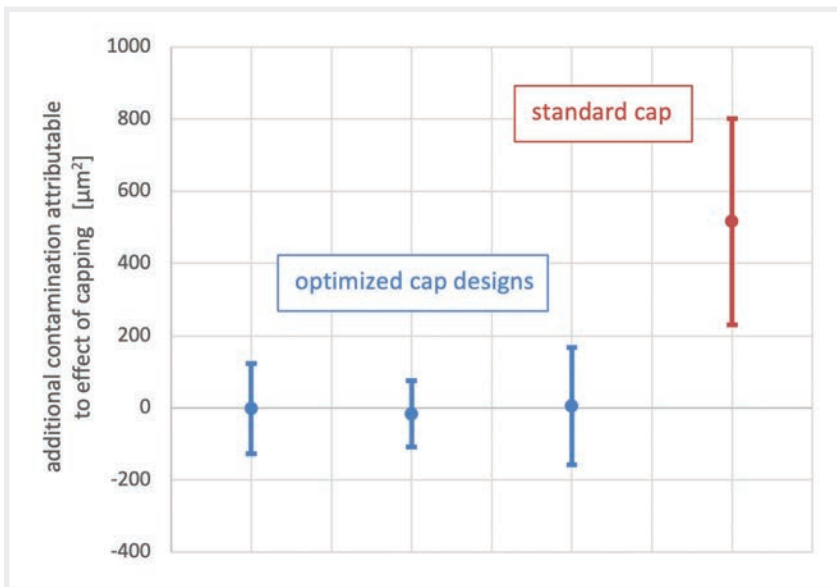
Figure 16: Final minus initial debris area after capping and uncapping clean LC connectors (with 95% confidence level error bars) for four different cap designs, three optimized designs, and one standard design.

In the course of this work we tried a number of standard and optimized cap designs and measured the effect of each on end-face contamination after capping/uncapping, in some cases with the connectors being shipped before uncapping and inspection. As shown in Figure 16 below, we found that only the standard caps added any contamination to the connector end face.
